SUPERCUT ROTOR HUB REPAIR

Rotor spigot alignment- Rotor Hub repair kit 7191605

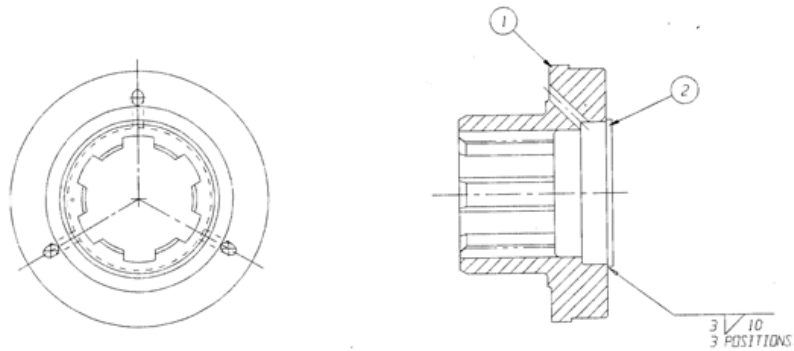
7191391

Early supercut rotors were only splined at one end, later ones were splined at both ends so they could be turned round when the first spline wore out.

A 6 spline weld in drive hub kit, part number 7191605, is available to repair these rotors. It includes the coupling, part number 7191391, shown below, but not the 6 spline drive coupling, part number 7190573 (sold as 7190580 coupling and grease)
